Real Estate Inspection Report and Additional Information

123 Tennyson St., Westminster, CO

Inspection Date:
07/11/2016

INSPECTION REPORT SUMMARY

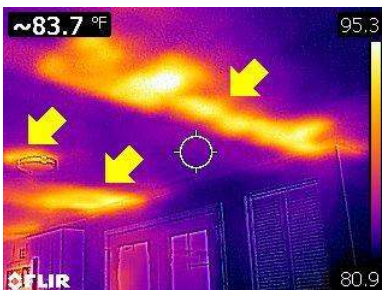
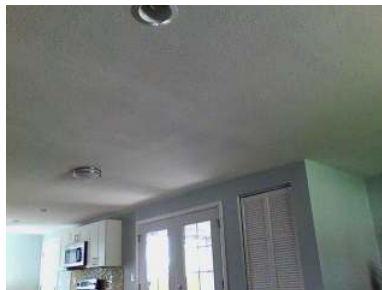
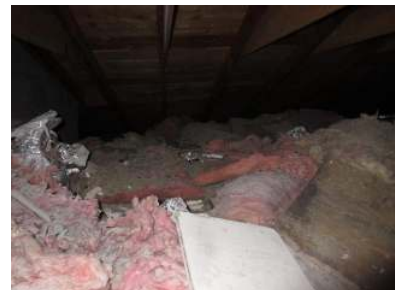
As observed in the living space using an infrared camera, many medium to large size "hot spots" indicating a lack of insulation were observed on the ceiling throughout the main level. As observed in the attic, many areas of disturbed or missing insulation were observed. It is proper building practice to use loose fill, rather than the installed fiberglass batting, to insulate an attic space. We recommend further inspection and installation of proper attic insulation by a professional attic insulation installation contractor.

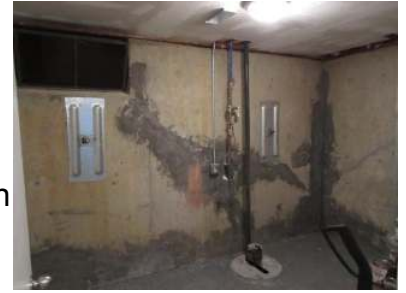
Significant structural repairs have been completed on the house foundation. Structural repairs should be supervised by a licensed structural engineer. Structural repair documentation should include an initial assessment and correction plan by a structural engineer, a receipt from a repair contractor detailing repairs completed, a document from the structural engineer indicating that the repairs were properly completed per the initial plan, and a completed building permit from the local building department. We recommend asking the current owner for copies of all of these documents. Assessing the installation and performance of these repairs and documentation is beyond the scope of this inspection.

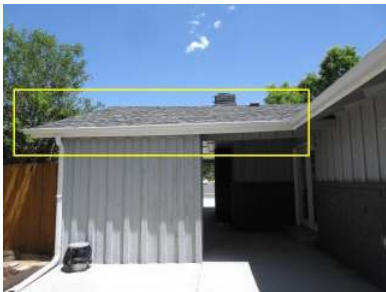
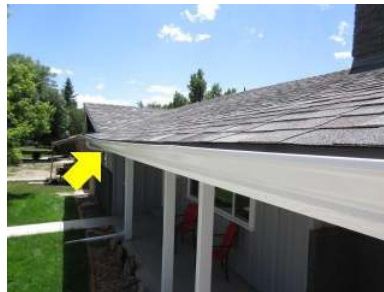
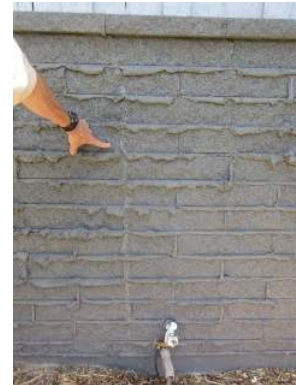
- As observed from the backyard, the roof over the rear carport was sloping slightly indicating settling at this point.
- As observed at the front of the house, the edge of the roof, fascia board and soffit were sagging in some places and not flat-and-level across the front of the house.
- 9 vertical repaired cracks, most approximately 4.5' tall, were observed in the brick veneer walls around all 4 sides of the house.
- Minor to moderate sloping floors were observed in some areas of the main floor of the house.
- The double exterior patio doors were rubbing and unable to open/close smoothly.
- The rear exterior door did no latch closed properly and outdoor light was observed at the top indicating a poor seal.

We recommend reviewing all of these issues with a licensed structural engineer.

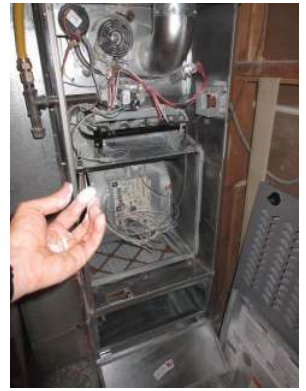
A significant amount of drywall dust was observed on the furnace blower fan blades. This is caused by operating the furnace during the remodeling construction of this house. Dust build-up on the blower can restrict the flow of air through the system and negatively effect the function of the heating system. Proper correction should involve significant disassembly (including removal of the blower), a thorough cleaning, re-assembly and tuning by a professional HVAC contractor.

If the furnace is coated with this white drywall/construction dust, it is likely that the inside of the ductwork is coated as well. Correction will involve having the duct system professionally cleaned.

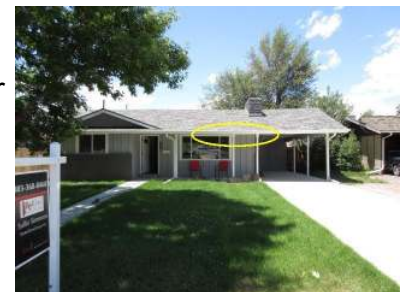
The gutter across the front of the house is sagging slightly near the center and is not sloping to direct drainage water towards the downspout in this area. This may result in water overflowing this area in times of heavy rain and may shorten the life of the gutter due to standing water. Correction may involve re-installation of the gutter by a gutter repair contractor.

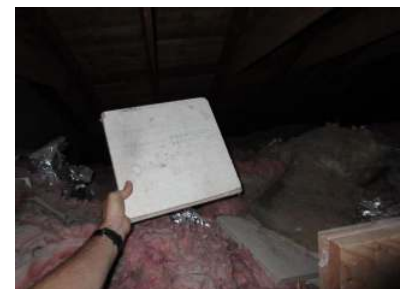
One old fiber 10" x 10" ceiling panel was observed in the attic near the hatch door. These panels can sometimes contain Asbestos fibers. Correction should involve further inspection and removal of these panels from the attic.

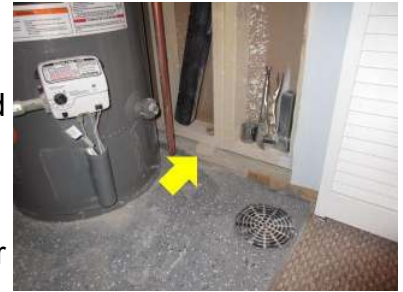
One 2"x4" spacer block was still installed in the bottom of the "floating wall" adjacent to the furnace. Spacer blocks are used for initial installation but should have been removed to allow the wall to float properly. We are unable to determine if spacer blocks have been left in place in the other finished basement walls. We recommend that this and all other spacer blocks be removed.

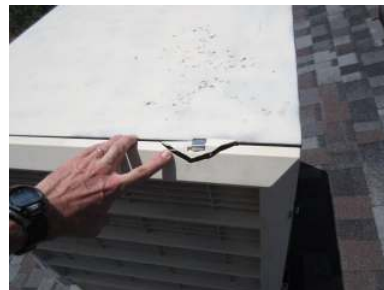
- The evaporative cooling unit did not respond to user controls in the "Low Fan" and "Low Cool" settings.
- As observed on the roof, a constant water drip was observed from the rear left corner of the unit where water is overflowing the tray inside the unit.
- Several of the door clips were unable to secure the door on one side.

Correction should involve further inspection and repair as necessary by a qualified evaporative cooling service contractor.

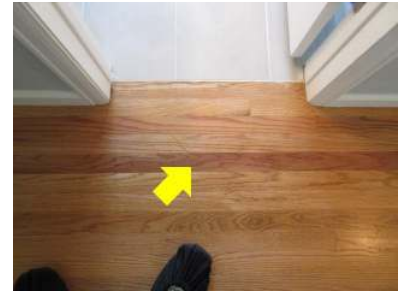
Several moderate scratches were observed in the wood floors. These are cosmetic deficiencies. Correction will involve sanding and refinishing all of the floors on this level of the house.

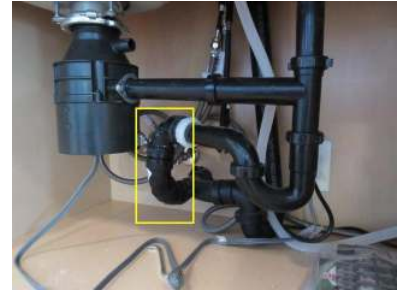
The horizontal section of the sink drain located after the drain trap dropped 3" where it should extend horizontally into the vertical pipe to allow for proper venting. Under certain circumstances this can keep the sink from draining properly. Correction should involve repair by a professional plumber.

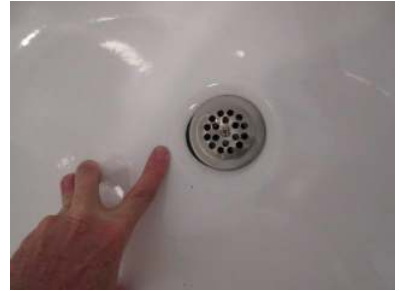
The drain alignment was off by approximately 3/8" at the basement bathtub. Correction will allow repositioning of the drain.

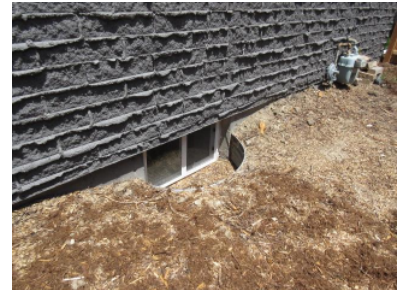
The soil/landscaping was observed to be at the same level as the top edge of a metal window well at the left side of the house. This may allow surface water to enter the window well and could result in moisture entering the basement. It is proper practice to have several inches between the soil/grading and the top edge of the window well. Correction may involve the installation of a window well extension, or replacement of the entire window well.
