Real Estate Inspection Report and Additional Information

S. Havana Street, Englewood, CO

Inspection Date:
07/15/2016

INSPECTION REPORT SUMMARY

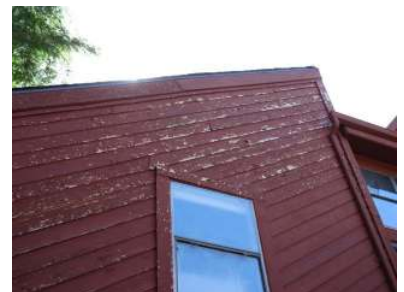
SIDING:

Much of the wood siding on the building was old, weathered, worn, and in fair condition. The paint/stain was weathered, worn, peeling and missing in many areas. Correction will involve siding repair and significant repainting.

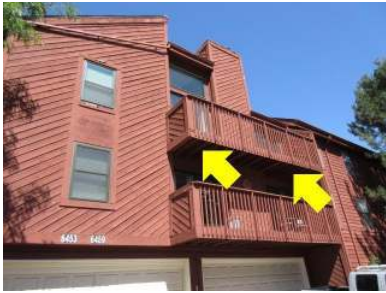
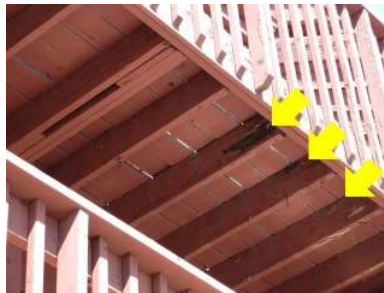
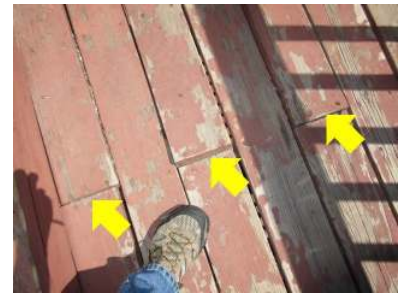
BALCONY DECK:

As observed from the ground looking up at the bottom of the deck, and from the deck surface, areas of significant moisture damage/rot were observed on the joists under the deck. The ends of several deck surface boards were loose and sticking up since the screws are not able to hold in the rotted joists. In our opinion, these conditions could result in partial or complete collapse of the deck which can result in serious injury or death. Since the deck is old, proper correction should involve replacement of the entire deck system. We recommend contacting the HOA to discuss their plan for replacing this deck. We recommend that the deck not be used until it is repaired.

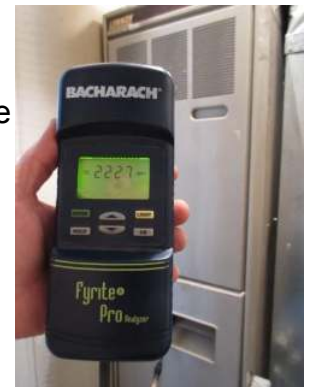
CARBON MONOXIDE:

Very high levels of Carbon Monoxide "CO" gasses of over 2,200 parts per million were detected in the vent gasses leaving the furnace when tested with a Bacharach Fyrite Pro CO testing device after operating the furnace for a short time. A normal level of Carbon Monoxide in these vent gasses should be under 30 ppm. Although these vent gasses are exiting the furnace/house through the metal vent pipe, and no Carbon Monoxide was detected in the house air, these levels are an indication of a serious problem with the furnace. Although unlikely, this would be a serious life safety danger if the vent gasses were to enter the living space. We recommend further inspection and correction as necessary by a qualified HVAC contractor prior to operating this furnace. Since the furnace is 37 years old, correction should involve replacement of the furnace.

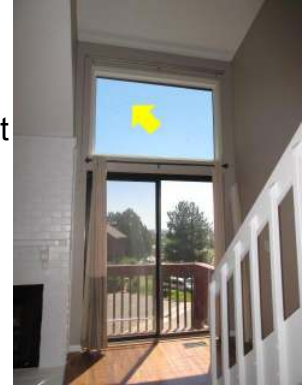
WINDOW GLASS

An approximate 4' long crack was observed in the glass of one window above the sliding glass door. This may be a result of a defect in the glass or damage during installation. This window appears to be newer and may be under warranty. Correction will involve replacement of the glass unit.

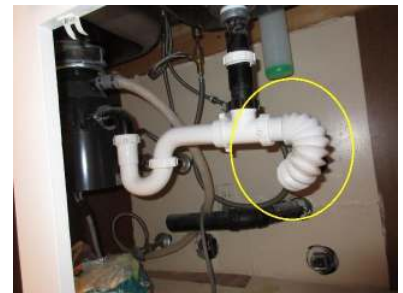
SINK DRAIN:

No trap was observed in the plumbing drain under the right side of the sink. The purpose of a trap is to keep potentially dangerous sewer gasses from entering the living space. Correction should involve the installation of a proper drain trap by a professional plumber.

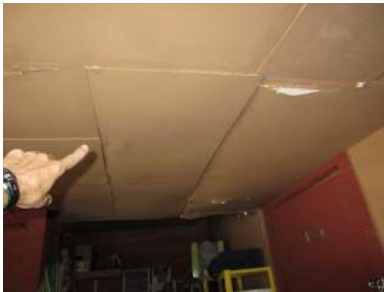
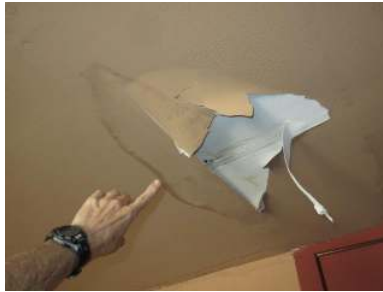
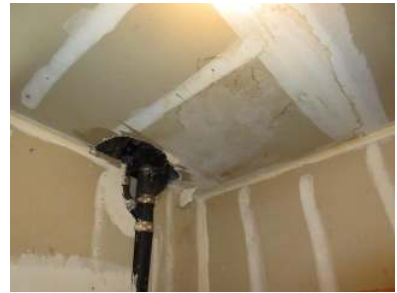
FIRE BARRIER:

Many indications of previous water leaks and poor quality repairs were observed on the ceiling and walls of the garage and storage room. These are breaches in the firewall between the garage and the living spaces. It is proper practice to have a firewall, consisting of 5/8" thick drywall, joints taped and covered with joint compound, between the garage and any living space. Correction will involve repair as necessary.

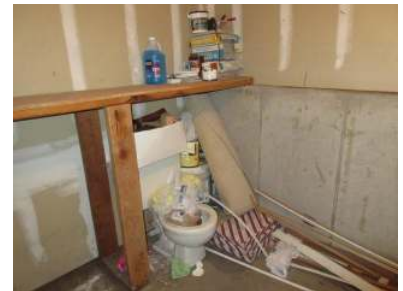
OBSERVATIONS:

Some storage items were observed in the garage storage room including an old toilet. Consideration should be given to asking the current owner to remove these items.

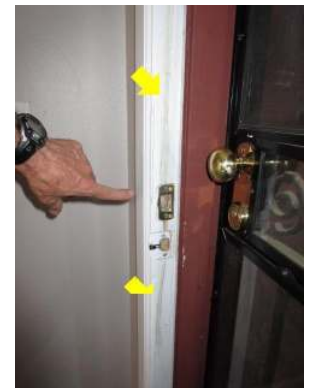
MAIN ENTRY DOOR:

A repaired crack was observed in the wood frame of the front entry door indicating forced entry at some point in time. The door is operational. Full repair may involve replacement of the entire door and frame.
