Real Estate Inspection Report and Additional Information

123 Summit View Dr., Louisville, CO

Inspection Date:
05/03/201X

INSPECTION SUMMARY / PUNCH LIST

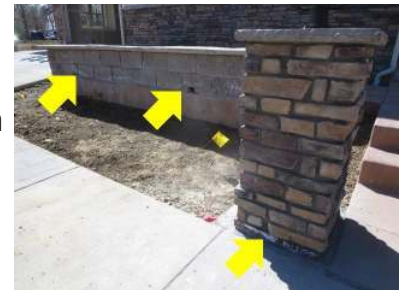
Efflorescence, a white colored residue, was observed on the front patio concrete block walls and on the stone at the bottom of several of the front posts. Efflorescence is a water soluble salt that is deposited on the surface of the stone by the evaporation of water that has partially penetrated these surfaces. This is a cosmetic deficiency that is not hurting the blocks and stone. Correction can typically be accomplished by scrubbing the walls with a stiff brush and clean water.

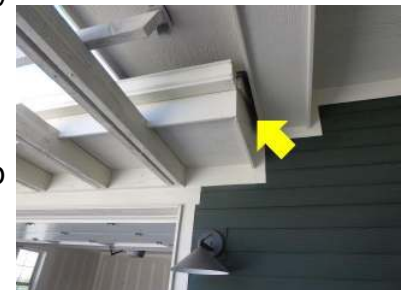
An approximate 18" x 1 1/2" gap was observed in the soffit area at the left side of the front porch. This is a potential wasp and bee entry area into the soffit. Correction should involve closing off this gap as necessary.

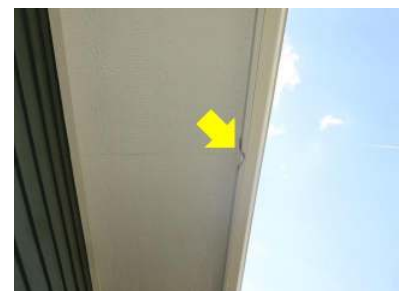
Mechanical damage was observed in a 6" area of the fascia board at the right side of the house. Correction will involve repair or replacement as necessary.

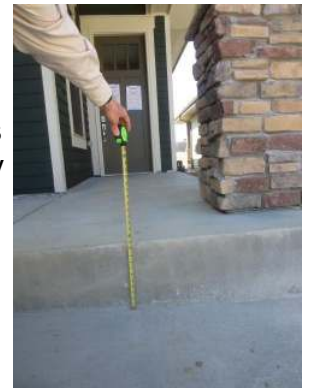
An 11" tall step was observed from the driveway to the front porch as measured at the logical walking path directly in front of the front entry door. It is proper practice that step riser heights not exceed 7 3/4". This is a potential trip/safety hazard. Correction may involve the installation of a second step at this walking path point.

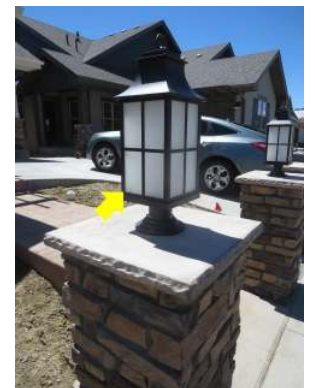
A 1" crack was observed in one of the glass panes of the left side stone post light fixture at the front of the property. Correction will involve replacement of the glass.

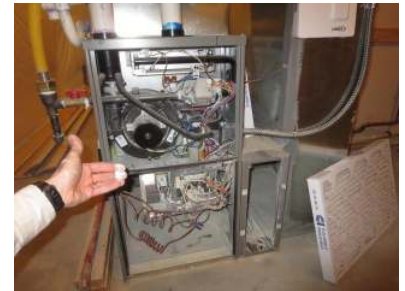
A significant amount of drywall dust was observed on the blower fan blades, and on the inside of the lower cabinet and plenum of the furnace. This is caused by operating the furnace during the construction of this new house. If the furnace is this dirty, the AC coil (not visible) is likely to be coated with dust as well. Dust build-up on the blower and AC evaporator coil can restrict the flow of air through the system and negatively effect the function of the heating and air conditioning systems. Proper correction should involve significant disassembly (including removal of the blower, access to the heat exchanger and cleaning of the evaporator coil), a thorough cleaning, re-assembly and tuning by a professional HVAC contractor.

If the furnace is coated with this white drywall/construction dust, it is likely that the inside of the ductwork is coated as well. Correction will involve having the duct system professionally cleaned.

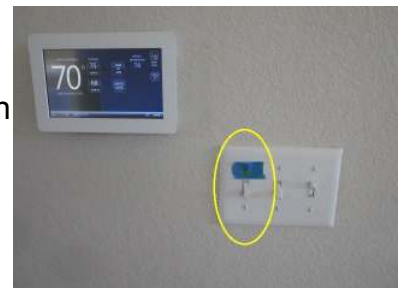
A light switch was found at the left front of the main level main room where the controlled light fixture, outlet or appliance was not identified. We marked this switch with a piece of blue tape. It makes sense that this switch should be the

second switch to control several recessed lights in this room where the other switch is at the rear of the kitchen. We recommend asking the builder about the function of this switch.

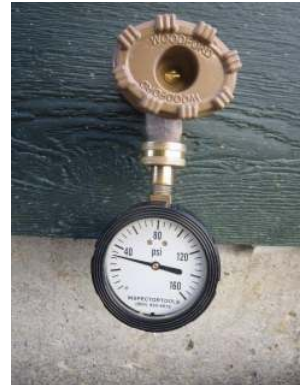
The water system pressure, as measured at an outdoor faucet, was observed to be between 30 and 35 psi. This is slightly below the recommended 45-65 psi range for residential homes. A Pressure Regulator, which reduces the water pressure as it enters the house, was observed on this system in the mechanical room. The low pressure may be an indication that the regulator is not adjusted properly or may be defective. Correction may involve adjustment or replacement.

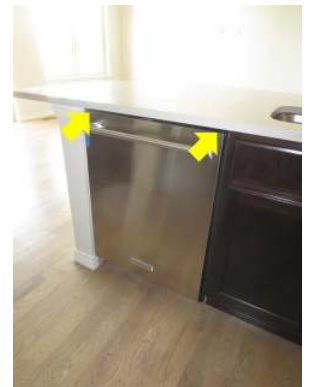
The dishwasher was installed slightly crooked where the horizontal edge at the top of the dishwasher was almost 1/2" different front one side to the other when measured to the edge of the countertop.
