Real Estate Inspection Report and Additional Information

321 Vrain St., Denver, CO

Inspection Date:
08/08/201X

INSPECTION SUMMARY / PUNCH LIST

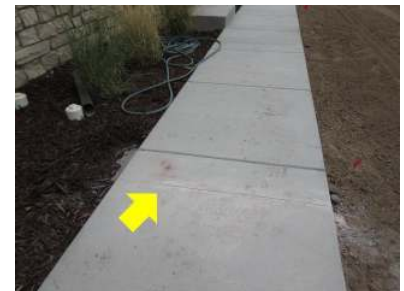
An unfinished concrete saw cut was observed in the sidewalk at the front of the house. It appears that this is intended to install a channel drain. We recommend asking the builder about this issue.

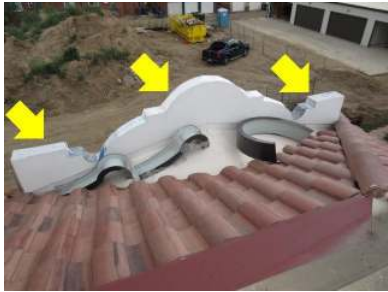
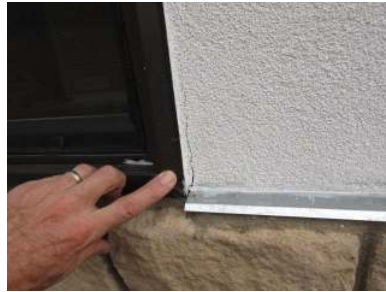
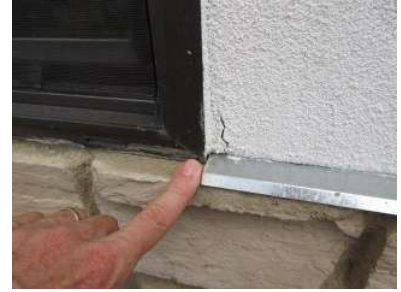
- No metal flashing was installed at the top edge of the parapet wall at the upper front of the house.
- Several minor potential moisture entry cracks were observed on the stucco walls at the bottoms of windows, and around the garage door wood framing. Correction should involve sealing these areas with special stucco caulking.
- No caulking was installed around 3 wall mounted light fixtures where they are installed on the stucco walls. It is proper practice that the sides and tops of the fixtures be sealed with an appropriate caulking (typically clear silicone) to prevent moisture from entering the wall behind the fixture.

Several minor potential moisture entry cracks were observed on the stucco walls at the bottoms of windows, and around the garage door wood framing. Correction should involve sealing these areas with special stucco caulking.

No caulking was installed around 3 wall mounted light fixtures where they are installed on the stucco walls. It is proper practice that the sides and tops of the fixtures be sealed with an appropriate caulking (typically clear silicone) to prevent moisture from entering the wall behind the fixture.

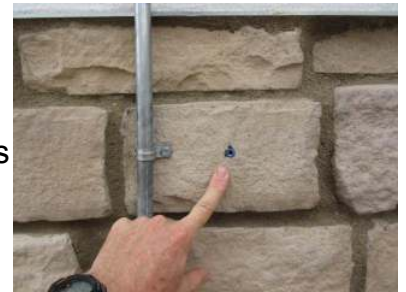
Minor moisture entry cracks were observed between the stone wall and the vertical wood framing on both sides of the garage auto door. Correction may involve sealing these gaps with mortar repair caulking.

3 abandoned 1/4" holes with plastic anchors were observed in the stone wall at the left rear of the house. Correction should involve removal of the anchors and repair of the holes as necessary.

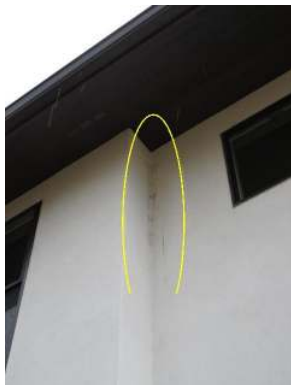
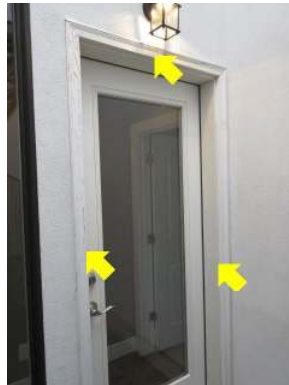
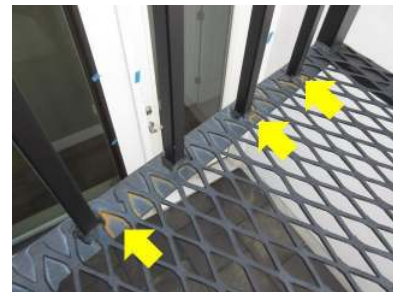
- Some areas of the exterior were dirty and in need of cleaning including the front door threshold, some of the walls, the auto door, and the vertical trim around the auto door.

- Discolored areas were observed at two inside corner areas, up to 3' x 10", at the upper left side wall.
- Many small grey spots, up to 1/8" diameter, were observed on the stucco walls around the front entry door and garage auto door.

- No paint was installed on the white plastic PVC vent pipe elbow at the rear of the house. It is proper practice to paint PVC pipes with an exterior grade paint to protect them from UV damage.

- No paint was installed on the exterior door frame and trim at the roof deck door.
- Many small rust spots were observed on the treads of the circular stairway leading to the roof deck.

- The inspector marked several finishing defects on the exterior of the house with pieces of blue tape. Correction and re-inspection are recommended.

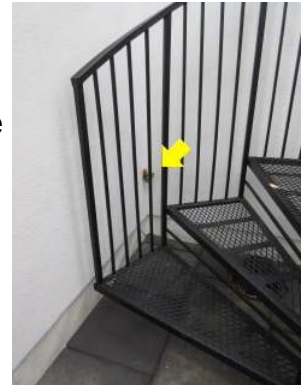
The faucet (hose bib) was located behind the circular stairway at the upper level deck area. This is a very poor location requiring someone to reach through the railing to access the faucet. Proper correction should involve re-location of the faucet.

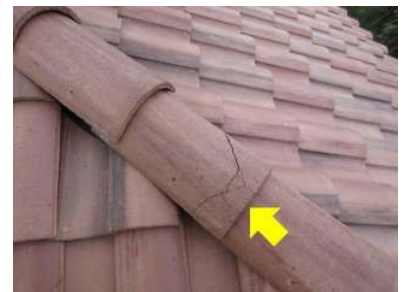
One cracked and broken ridge tile was observed at the left rear corner of the tile roof. Correction should involve replacement of the tile.

- TILE ROOF CONDITION:** One cracked and broken ridge tile was observed at the left rear corner of the tile roof. Correction should involve replacement of the tile.

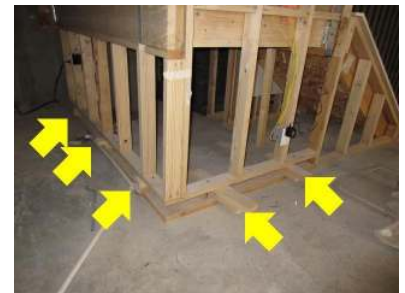
5 spacer blocks were still installed in the bottom of the floating framed walls in the basement. Correction will involve removal of the blocks.

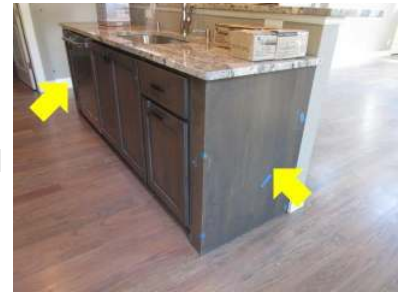
Significant scratching damage was observed on both cabinet end caps at the kitchen island. Full and proper correction will likely involve replacement of the end caps.

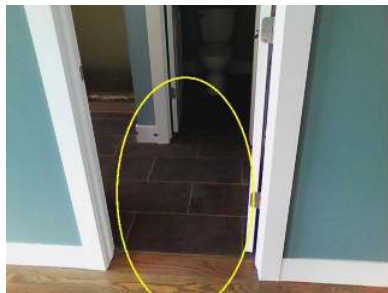
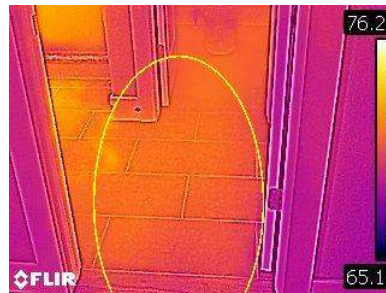
As observed using a Flir C2 Infrared Camera, although much of the master bathroom floor showed heat after turning up the thermostat, an approximate 7' x 3' area at the entry and leading to the toilet were not heated. It is common practice for these areas of a bathroom floor to be part of the floor heating area.
